**Durability Tests for the Labelase® 1000 Tag  
Printer Technology**

**Final Report**

**Oregon State University  
Mobile Technology Solutions Laboratory  
Revised 06/24/04**

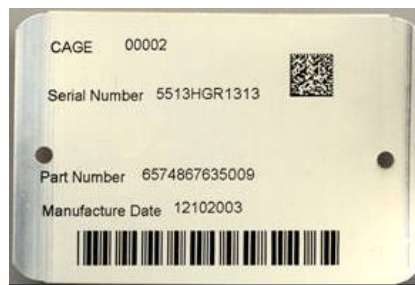
**Figure 1. Sample Tags Printed with the LabeLase® 1000 Tag Printer**

- **Infosight's LabeLase® 1000 tag printer.** The LabeLase® 1000 tag printer is designed to print high quality bar code symbols on standard 300-foot (90-meter) rolls of continuous metallic tag stock, pre-nick and notched for easy break off after printing. Figure 1 depicts a sample tag printed with the LabeLase® 1000 tag printer. These symbols are printed using CO<sub>2</sub> laser technology. The metal tag is covered with a proprietary silicone coating of which is discolored by the CO<sub>2</sub> laser to create both symbology and human readable information.

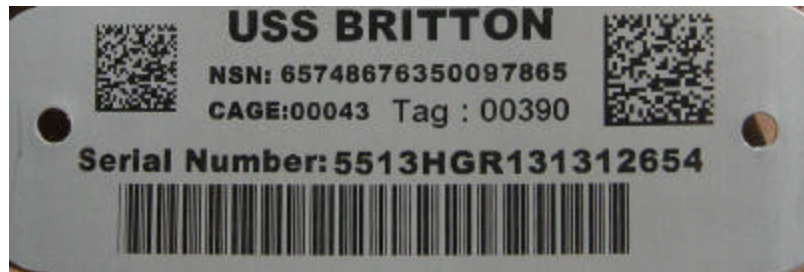
Figure 2. Labelase® Laser-marked Tags

- Code 39 bar code
  - 6574867630097865
- 14 mils Data Matrix symbol
  - ]>? 06? 17V00043? S5513HGR131312654? 1P65748676350097
- 17.5 mils Data Matrix symbol
  - ]>? 06? 17V00043? S5513HGR131312654? 1P65748676350097

Figure 2 depicts the layout of the Labelase® laser-marked tags.

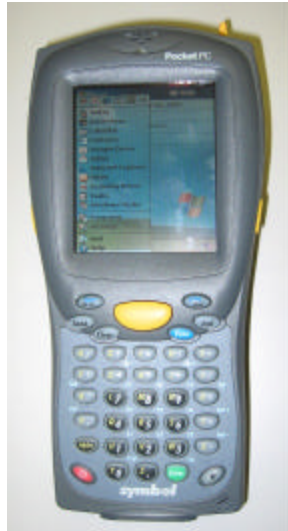
**Figure 3. Symbol Technologies’ PDT 8146-based DPM Prototype Reader**

A Portable Data Terminal from Symbol Technologies, model PDT 8146-based direct-part marking (DPM) prototype, was employed to scan the Code 39 and Data Matrix bar codes encoded onto the test tags. The PDT 8100 series reader “is a ruggedized handheld computer that features a powerful miniature imaging system with Smart Focus technology for superior image quality and fast, accurate bar code data capture at the point of activity.”<sup>1</sup> The PDT 8146-based DPM prototype reader is depicted in Figure 3.

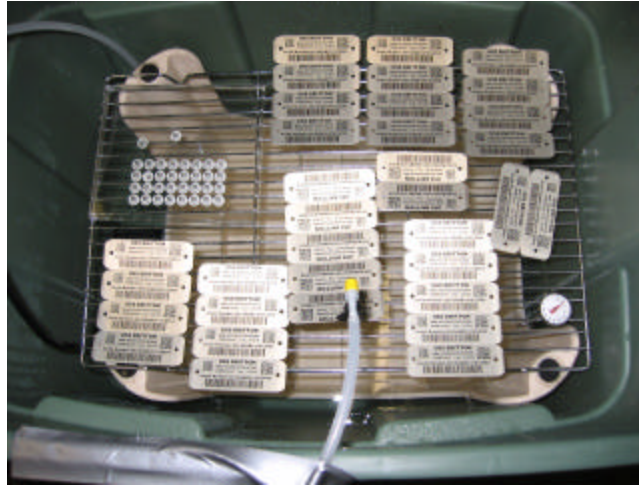
Figure 5. Salt Fog Chamber

The salt fog test was performed using a test chamber created for this purpose. This chamber is depicted in Figure 5.

To approximate the actual salinity of seawater, the saline solution used in the test was created using Instant Ocean® with a specific gravity adjusted to 1.023. The saline mix also included macro and micronutrients typically found in seawater (e.g., chloride, sodium, sulfate, and potassium, etc.). The temperature of the chamber's water supply was maintained at 95°F (35°C).

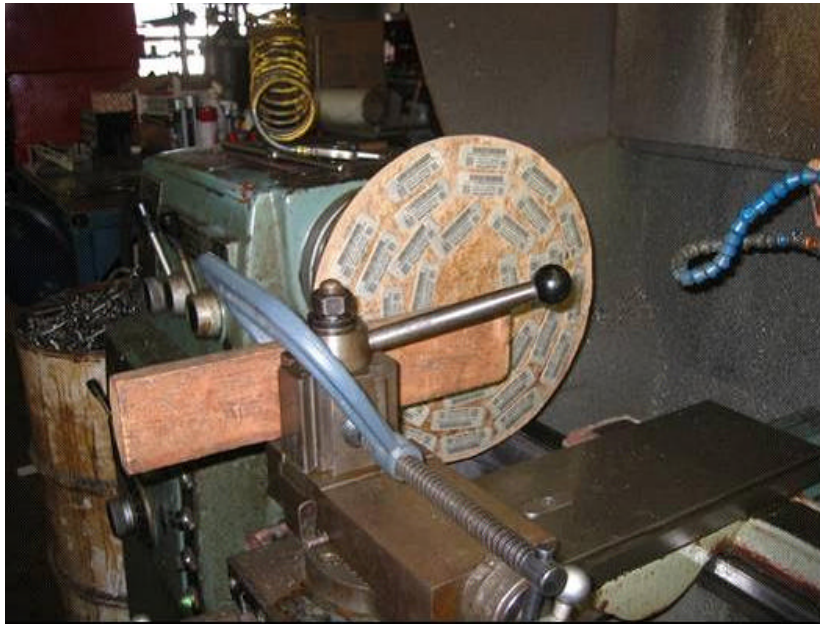
The abrasion test was performed using a fixture built specifically for the task. This fixture is depicted in Figure 7 and Figure 8.

In this test, no physical defects were found on the LabelLase® tags in the pre-visual inspection. All tags were successfully read before the abrasion process. The fixture that held the test samples was advanced until there was an audible sound from the contact with the sandpaper. The timer was started at the first sound of contact and the fixture was advanced an additional 10/1000 of an inch.

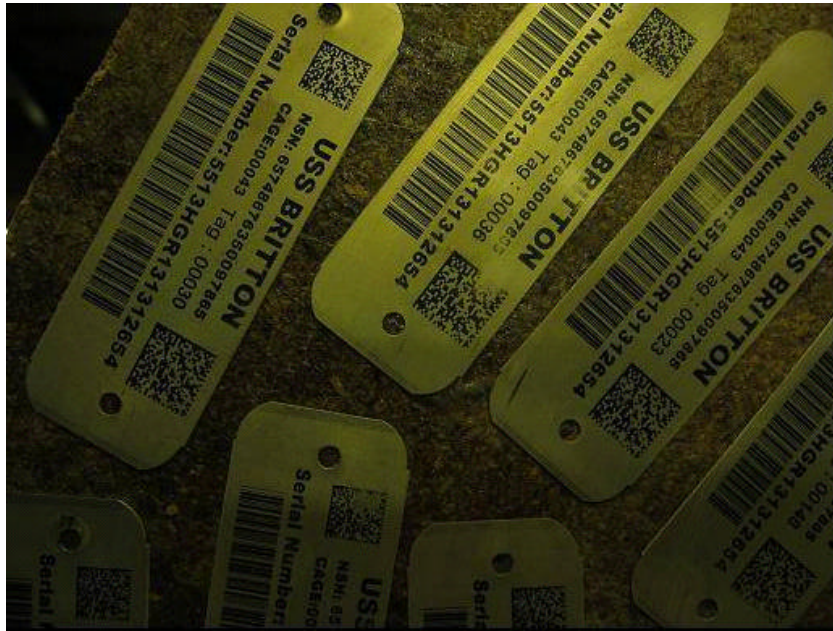
Figure 9. View of LabelLase® Damage after an Abrasion Run

Figure 9 depicts some of the damage incurred by the tags during the abrasion tests.

The results obtained in the abrasion test with the coarse sand paper (i.e., 40 grit) are shown in Table 9. The Labelase® tags withstood the first 15-second cycle of abrasion, failing in the second interval.

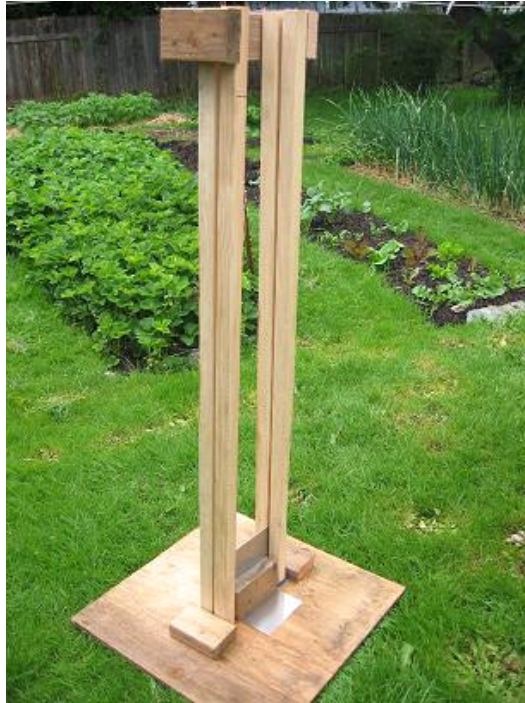
The impact fixture was built specifically for this test. The impact station was designed with a piece of 0.25 inch diameter steel rod attached to the bottom of the impact-sled. The tags were placed in the impact zone; the weight was attached to the sled and the sled was dropped from the prescribed height onto the tag, impacting the surface of the tag. The impact fixture is depicted in Figure 11 and Figure 12.

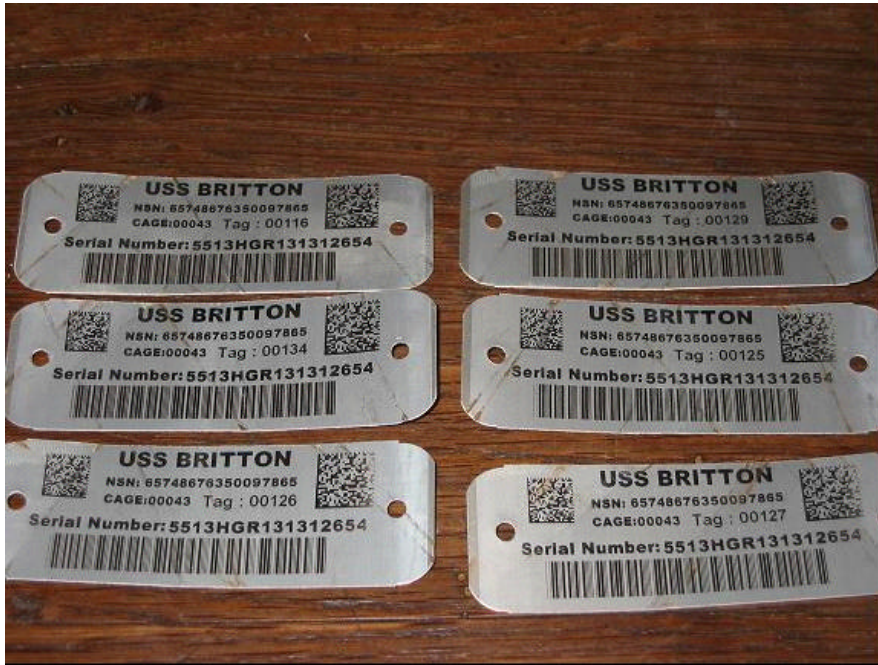
**Figure 13. Impact damage to tags after impact from three weights**

All LabeLase® tags passed the visual pre-inspection and were readable after the test was completed. This procedure was repeated with each successively heavier weight. All LabeLase® tags continued to perform and were readable even after the cumulative damage of all three impacts. The results are presented in Table 11. Figure 13 shows some of the damage incurred from the test procedure.

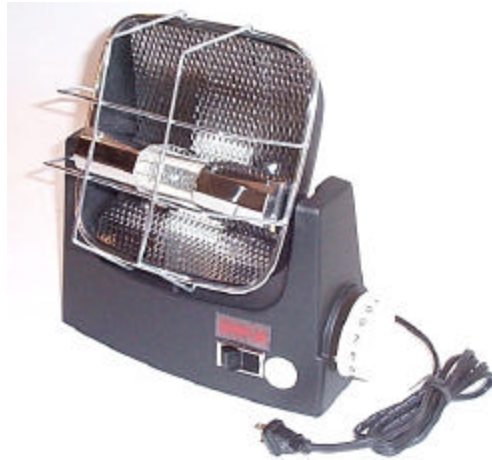
Figure 14. KBI's Ultraviolet Light Source

- Ultraviolet light source (see Figure 14).
  - Palm Springs Sunlamp
  - Manufactured by KBI Inc.
  - 700 watts of power
  - 70 % UVB
  - 30 % UVA

The ultraviolet light test was performed using a 700-watt UV lamp that produces 65% of its light in the UVA range (320-400 nanometers), and 35% of its light in the UVB range (280-320 nanometers). The LabeLase® tags were placed 15 inches away from the light source well within the footprint of the light. In this test, no physical defects were found on the LabeLase® in either the pre or post-visual inspection. All tags were successfully read before and after exposure to the ultraviolet light source. The results of the ultraviolet light test are summarized in Table 12.
